# NOISE REDUCTION OF THE IDA-RAISINVILLE SANITARY SEWER PIPE DISTRESS

September 1989

Final Report

11. TITLE (Include Security Classification) Investigation of the Ida-Raisinville Sanitary Sewer Pipe Distress					
12. PERSONAL AUTHOR(S) Leach, R. E.; Wong, G. S.; Mitchell, G. B.					
13a. TYPE OF REPORT Final report		13b. TIME COVERED FROM _____ TO _____		14. DATE OF REPORT (Year, Month, Day) September 1989

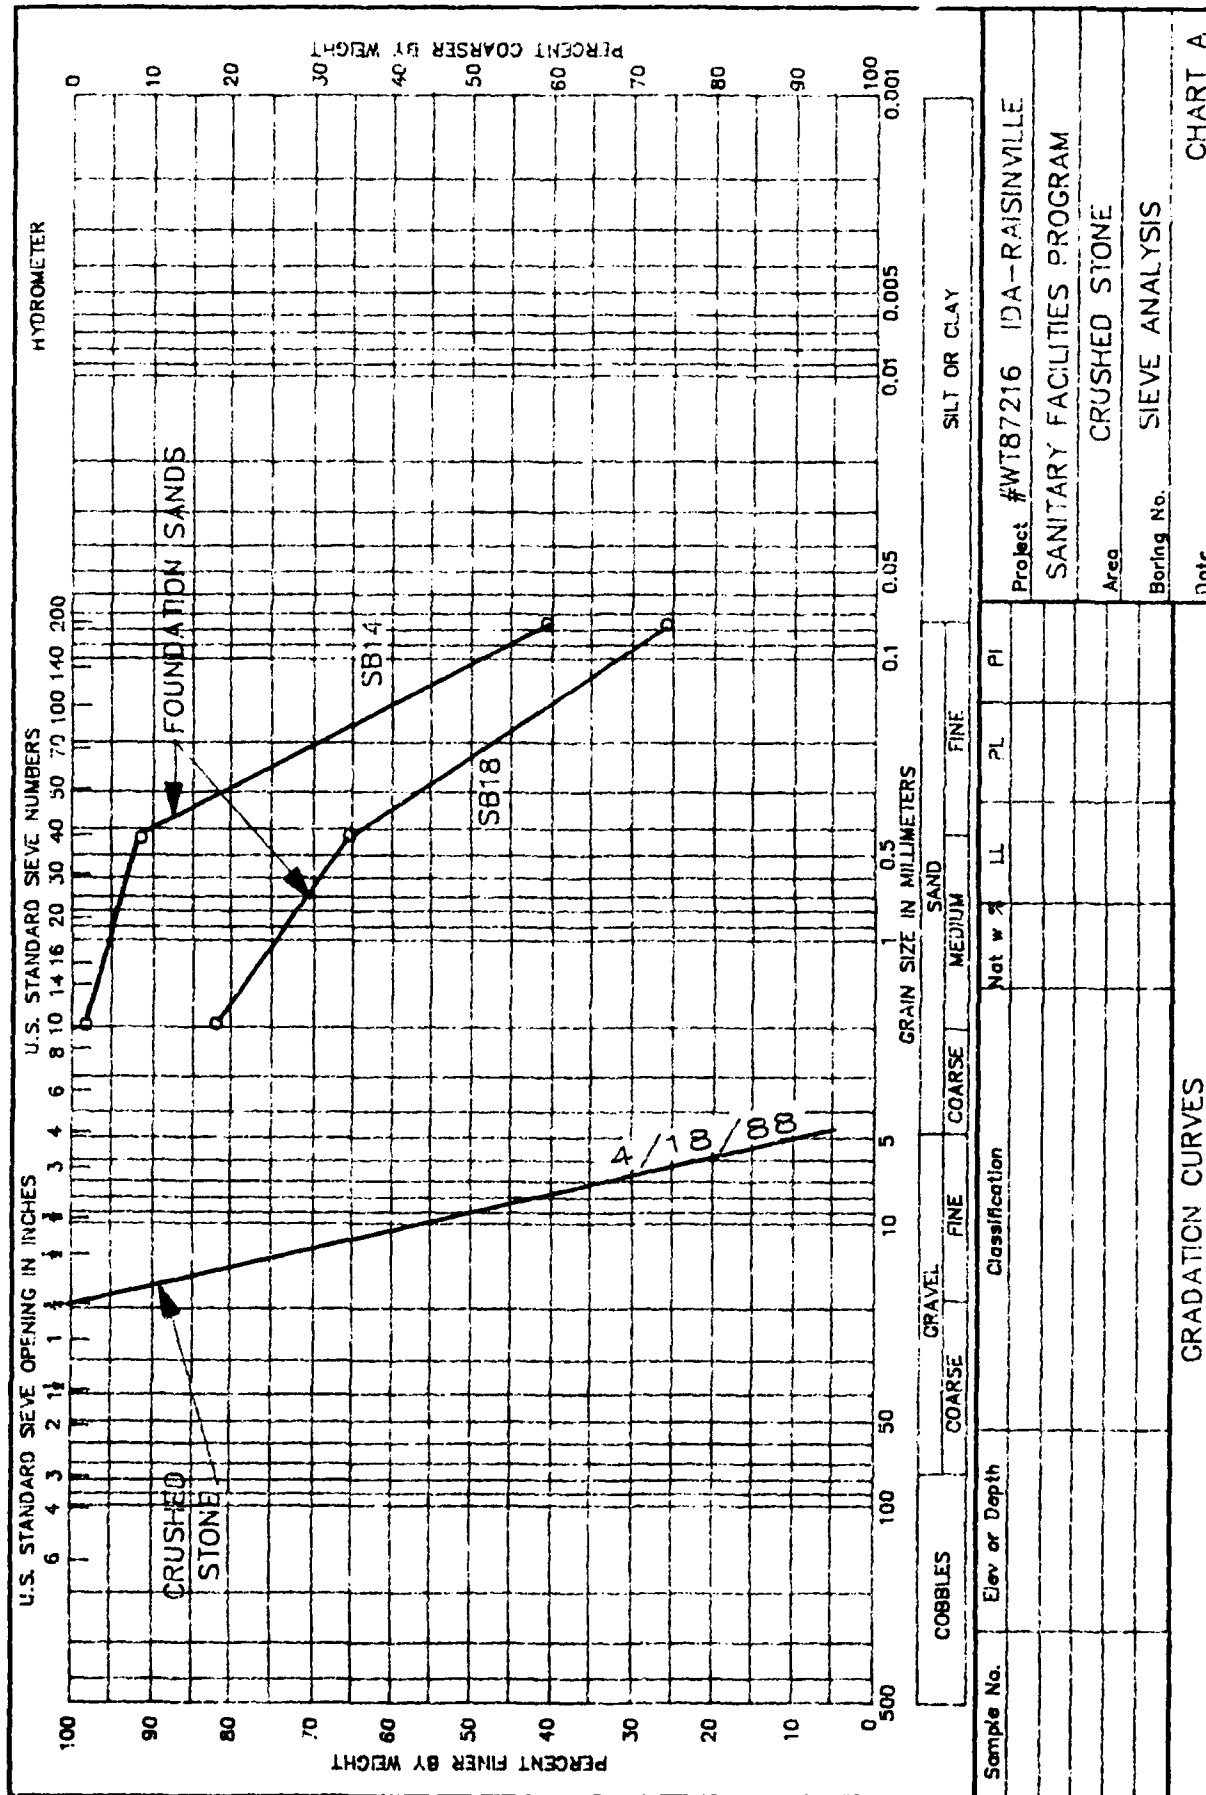
Figure 5. Grain Size Curve for Crushed Stone and Foundation Sands

9. The bedding material was brought in and placed in the bottom of the trench to provide a flat surface suitable for establishing specified grade for the installation of the pipe. This material along with the foundation materials when properly prepared should also assure that there was a minimum of differential movement along the base of the trench at the time of installation and later as the backfill was being added and compacted. The gradation of the bedding material is shown in Figures 5 and 6. The bedding stone, Figure 5, was a coarse material ranging from 3/4 inch down to 3/16 inch rock with less than 5% material below this size. The crushed limestone, Figure 6, ranged from approximately 1 inch down to 1/16 (No 10 sieve) inch with 25 to 50% of the material below this size. Also shown in Figures 5 and 6 are the grain size curves for the fine sand which comprised around 75% of the trench foundation material. Generally the bedding stone would not meet filter criteria for retention of the foundation sand if flow occurred or if pumping occurred from the vibratory compactor during backfill compaction. The crushed limestone would meet the criteria if segregation or bunching of the material was not allowed to occur.
